Project: BLM Lease/Grant N-86292
JBR/Stantec Project Code: 203711338

**Reference: Weekly Reporting (Week 177)
January 12, 2015 – January 18, 2015**

Week 177 CIC Inspection Photos

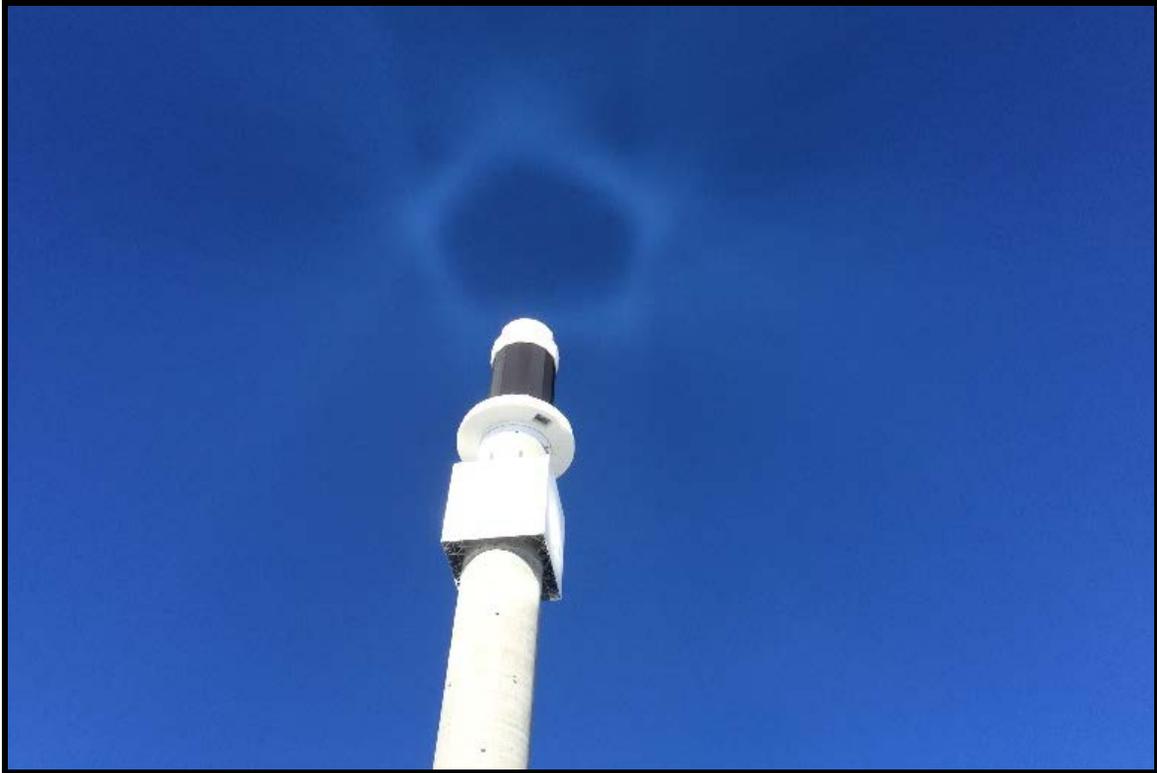
During Week 177, on January 14, 2015, there was an issue with bird mortalities during commissioning activities (Non-Compliance Incidence Stipulation #43). Approximately 3,000 heliostats were staged in a position which reflected light and heat to a concentrated point above the central tower. A halo above the tower was visible from the ground (Figure 1). The heat was so intense that birds flying into the halo were immediately burned and smoke was clearly evident. Approximately 115 mortalities were noted between 11:15 AM and 3:30 PM. Appropriate agencies, including BLM, were notified of the situation around 12:27 PM when bird mortalities associated with the halo were confirmed. Commissioning of heliostats was suspended until meetings with BLM could be held and, possible ways to mitigate bird mortality during commissioning could be discussed. On January 15, 2015, a meeting between the CIC Inspector (Seth Topham), bird mortality surveyors (Greg Sharp and John Lemback), BLM representatives (Tim Coward, Wendy Seley, and David Price), and Solar Reserve (Brian Painter) was held. Details of the bird incident were discussed and photos and video of the event were exchanged. In order to mitigate bird mortality, SolarReserve changed their strategy and offered to only stage 150 heliostats above the tower at a time. It was also decided that the CIC Inspector would be on site during all commissioning activities to monitor for bird mortalities and immediately notify SolarReserve should any mortalities occur. The CIC Inspector will have a two way radio with them at all times in order to maintain direct communication with SolarReserve. On Friday January 17, 2015, commissioning resumed with 150 heliostats on the north side of the tower. No birds were noticeably affected and a halo above the tower was not visible. Commissioning during the rest of Week 177 showed no signs of adverse effects to birds.

Figure 1 – The halo created by the reflected light of 3,000 heliostats which caused the bird mortalities.

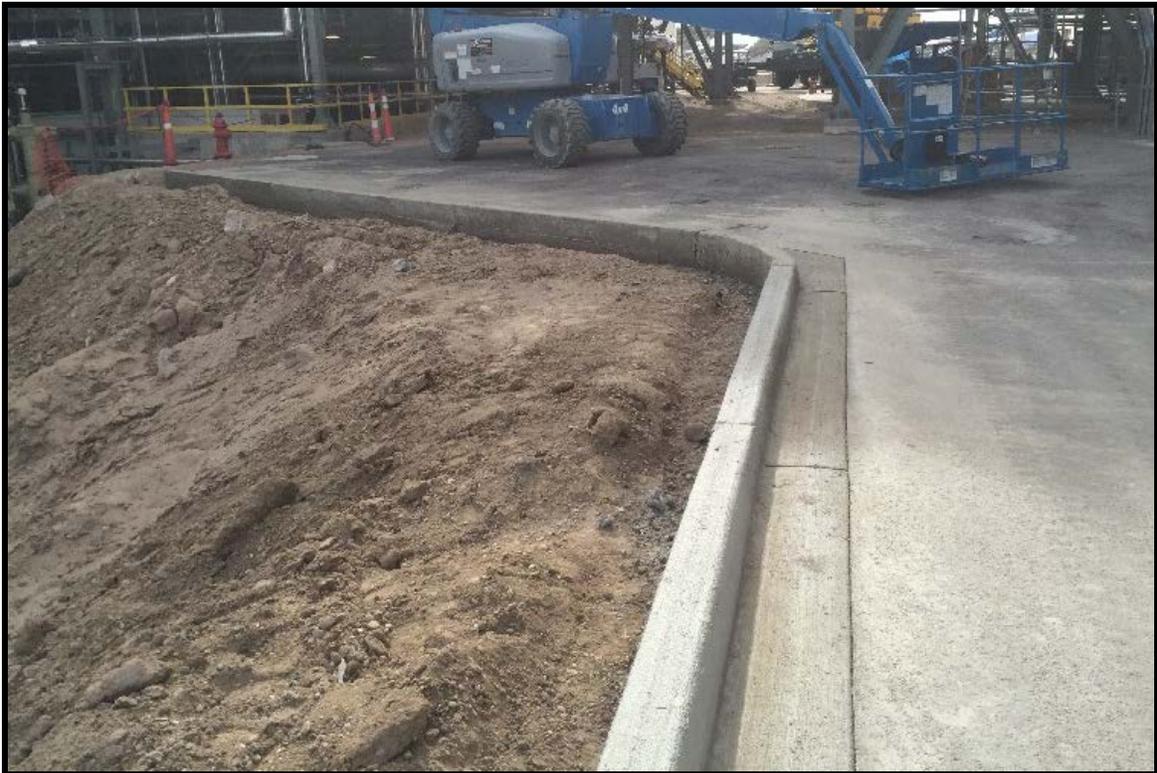
Bull Concrete had several concrete pours during Week 177. They poured a section of curb and gutter north of the tower within the Power Block (Figure 2). Bull Concrete also poured a pad just northwest of the second security gate (Figure 3). Concrete trucks washed out their shoots in an appropriate, clearly marked, wash out pit located east of the second security gate. After each pour the area was inspected by the CIC Inspector for any fuel/oil spills with none being found.

Figure 2 – Bull Concrete’s freshly poured curb and gutter on the north side of the Power Block.

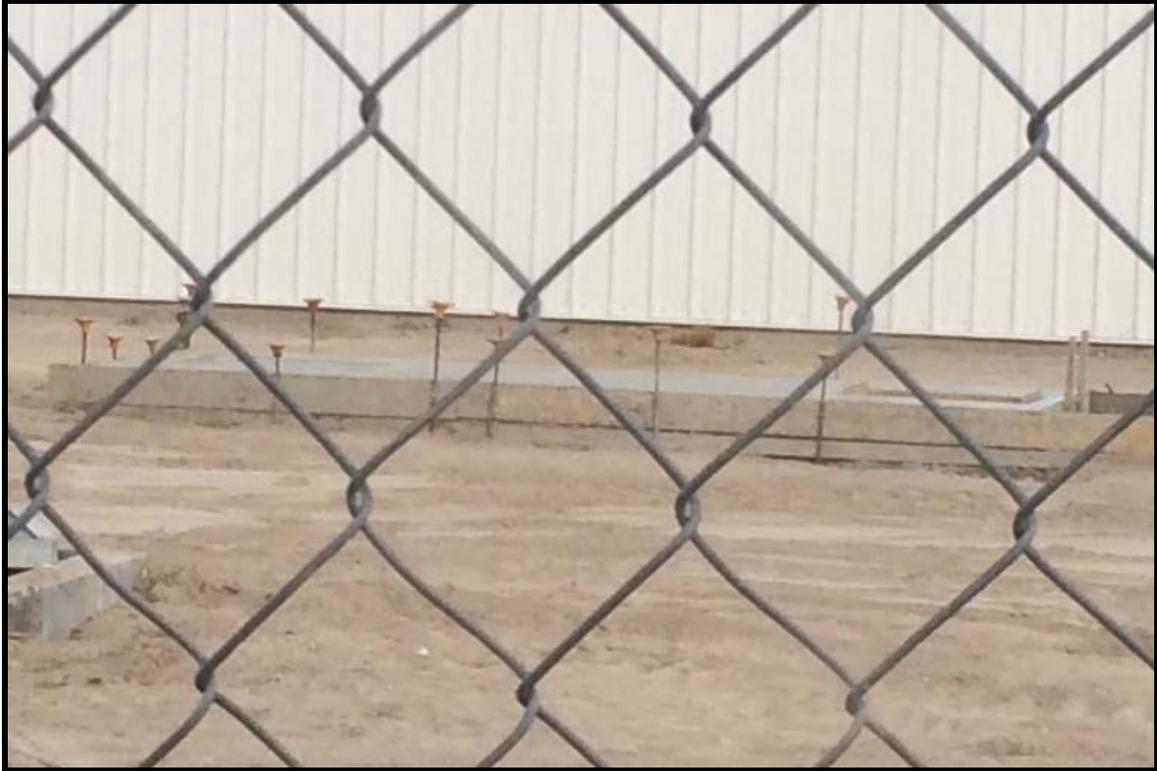
Figure 3 – Concrete pad poured by Bull Concrete during Week 177.

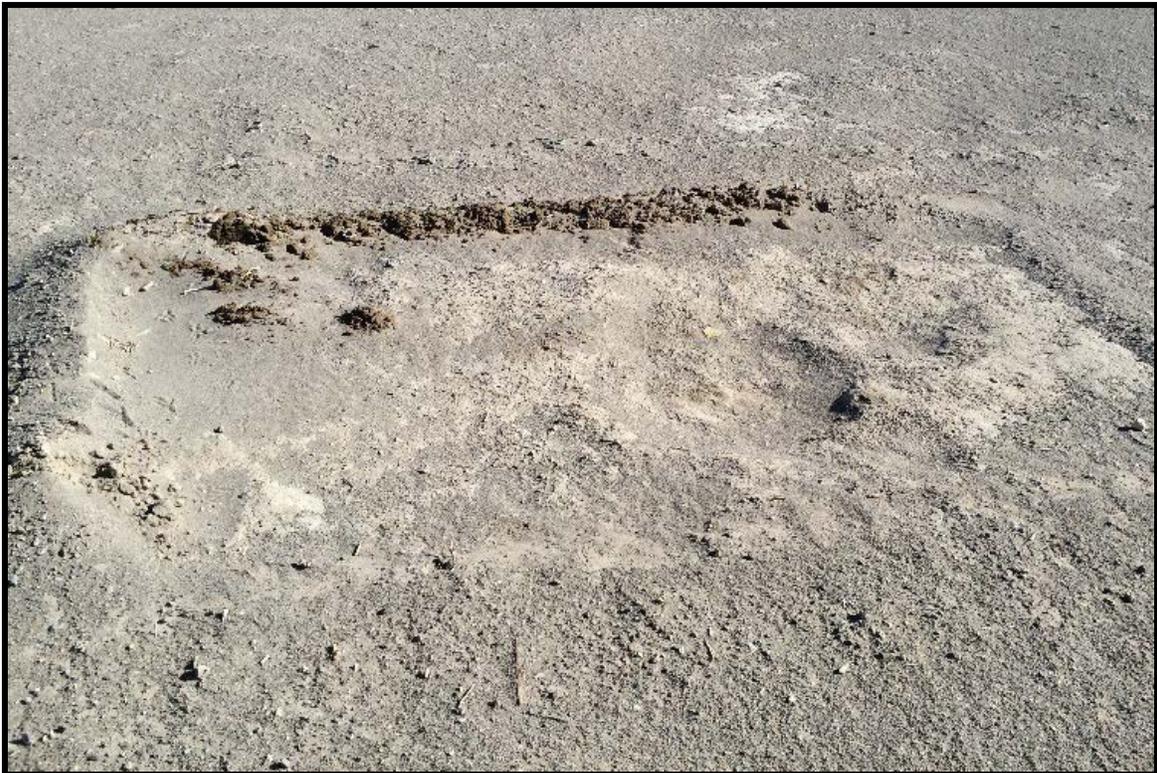
The two plastic lined fluid leak containment barriers where the plastic was removed and disposed of still contains contaminated soil which needs to be removed and properly disposed of (Figures 4 and 5). The contaminated soil is located just off the paved maintenance road east of the second security gate. Several contaminated soil stains also need to be cleaned up north of the second security gate (Figure 6).

Figure 4 – One of the two contaminant barriers that has had the wood and plastic picked up but still has a small amount of contaminated soil to be disposed of.

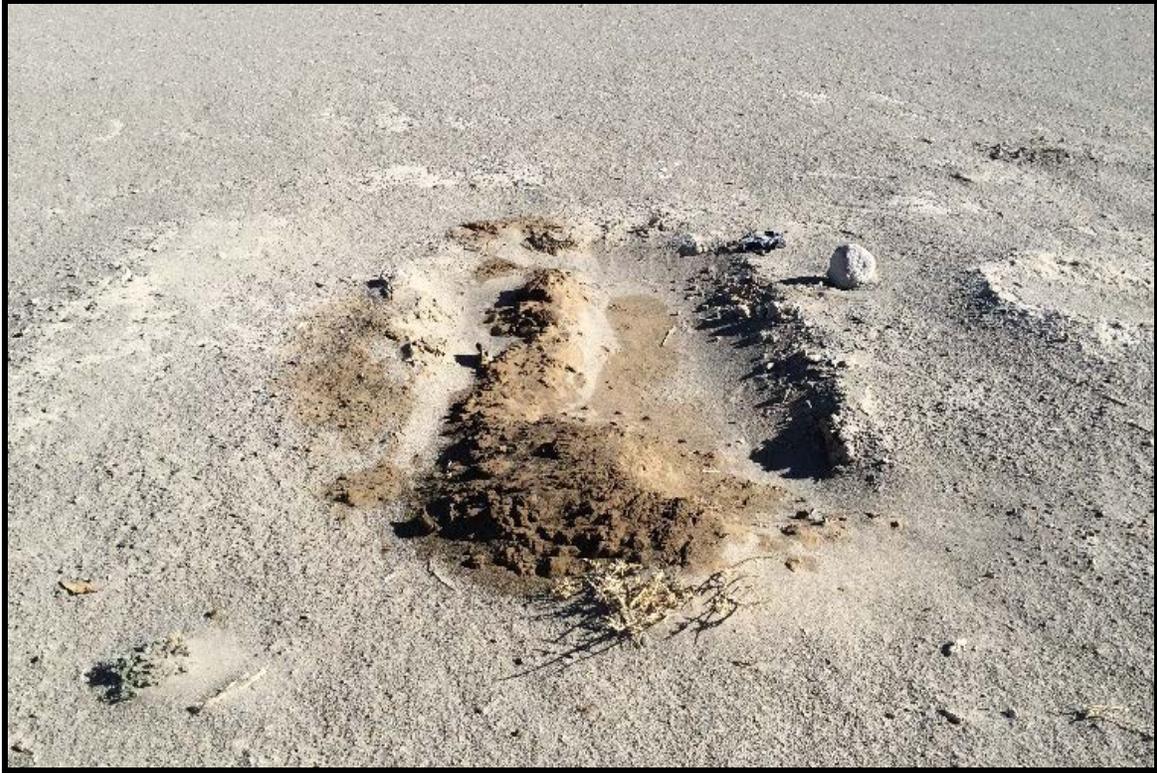
Figure 5 – The second of the two contaminant barriers that has had the wood and plastic picked up but still has a small amount of contaminated soil to be disposed of.

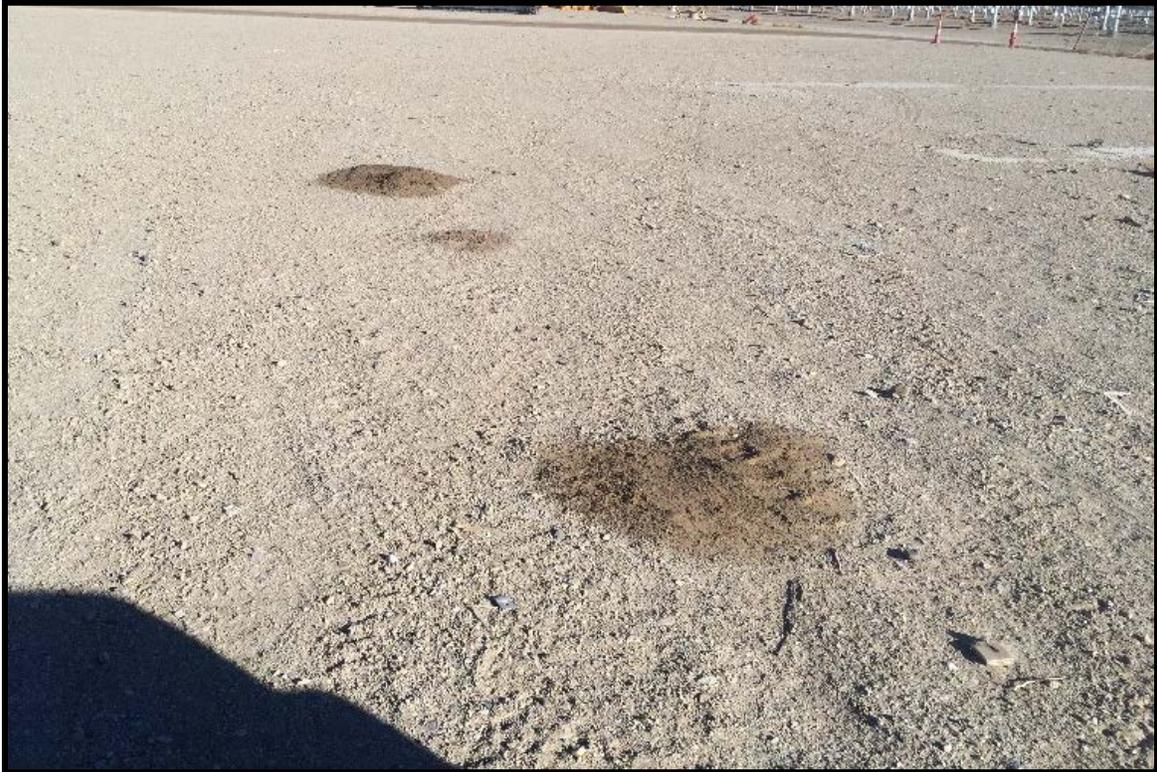
Figure 6 – Contaminated soil to be cleaned up north of the second security gate.

* 9:21 AM - CONTAMINATED SOIL NEEDS CLEANED UP JUST NORTH OF THE SECOND SECURITY GATE. (3 PATCHES)

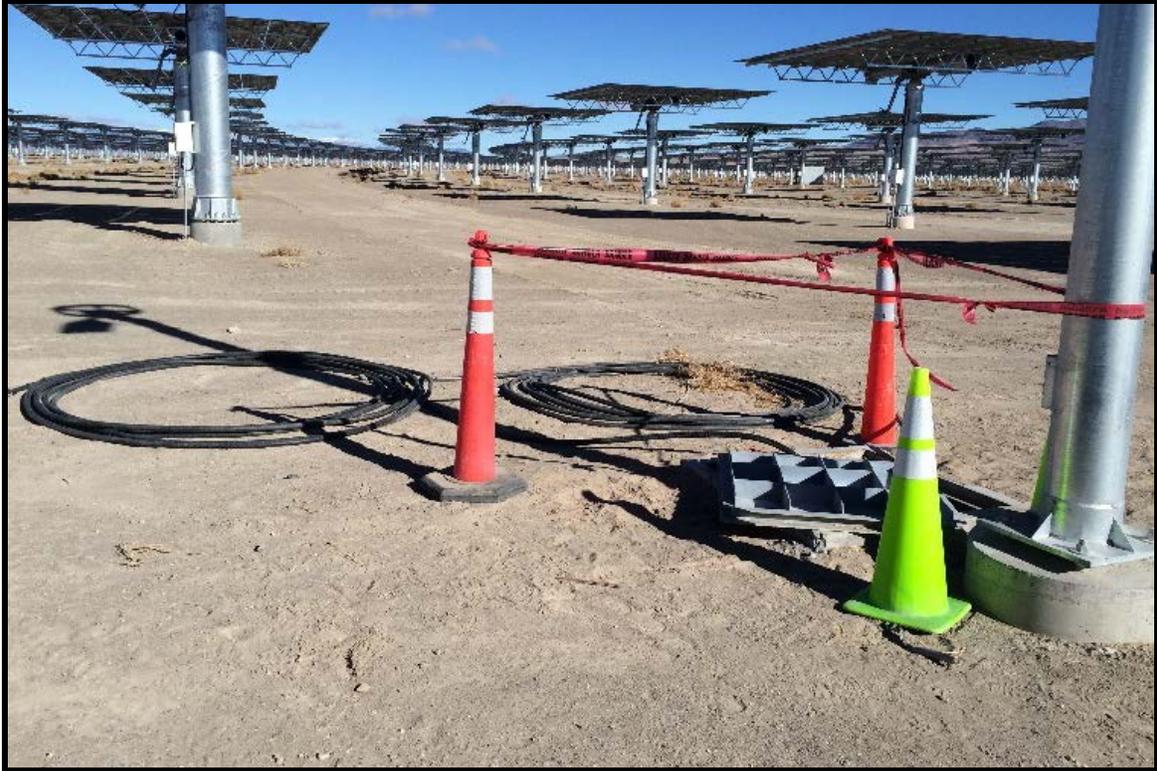
A new underground power conductor is still being installed along the main entrance road for power to the future office building (existing Cobra warehouse). Crews were still working to pull in a sheathed conductor via manholes (Figure 7).

Figure 7 – Electrical conductor lying in spools ready to be pulled into conduit via a manhole.
